# **The Road Inventory of Ridgefield National Wildlife Refuge Ridgefield, WA**

Prepared By:  
Federal Highway Administration  
Central Federal Lands Highway Division  
February 2013

## Ridgefield - 13551

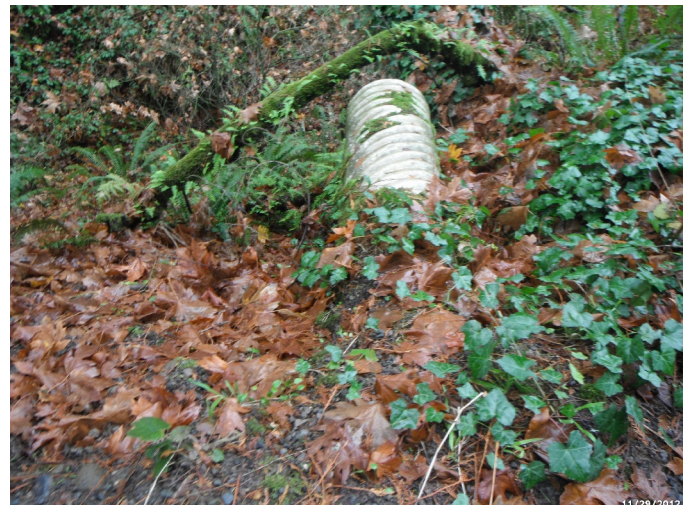
Photo: RIDG\_C4\_4202 Route: 010-001-0.2  
Metal Culvert 35ft long 18in dia. 2ft deep

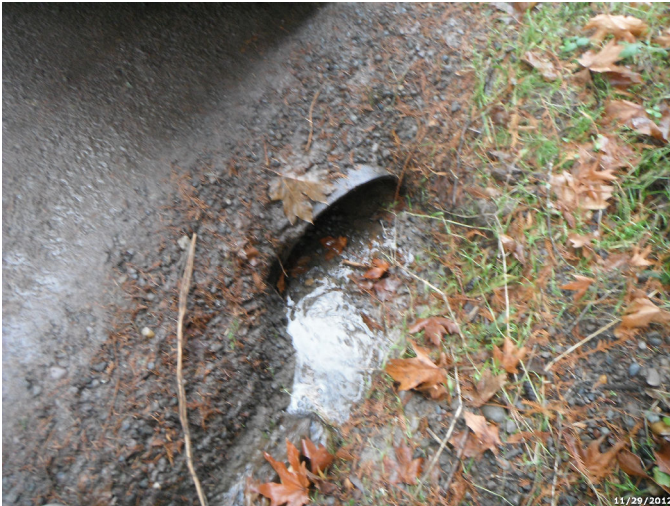
Photo: RIDG\_C4\_4203 Route: 010-001-0.2  
Metal Culvert 35ft long 18in dia. 2ft deep

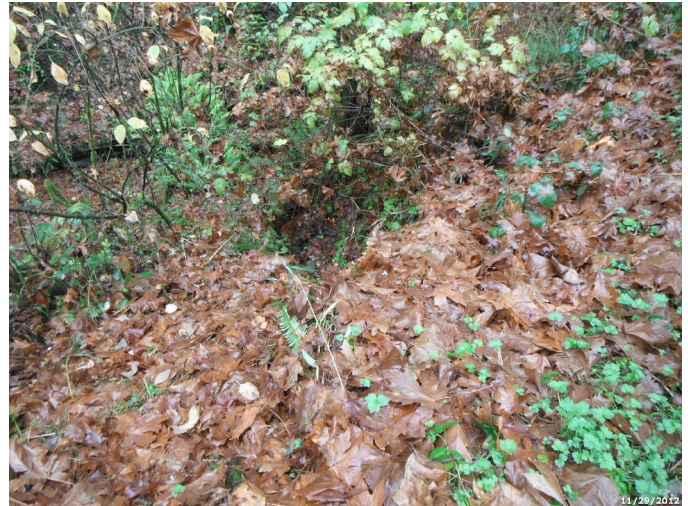
Photo: RIDG\_C4\_4204 Route: 010-001-0.24  
Metal Culvert 35ft long 18in dia. 2ft deep

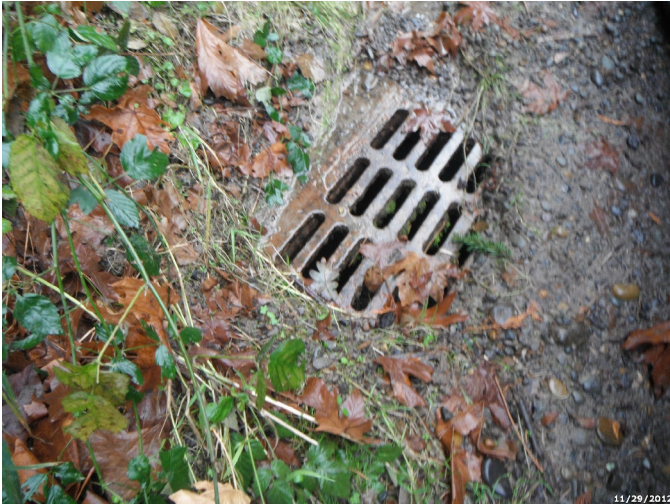
Photo: RIDG\_C4\_4205 Route: 010-001-0.24  
Metal Culvert 35ft long 18in dia. 2ft deep

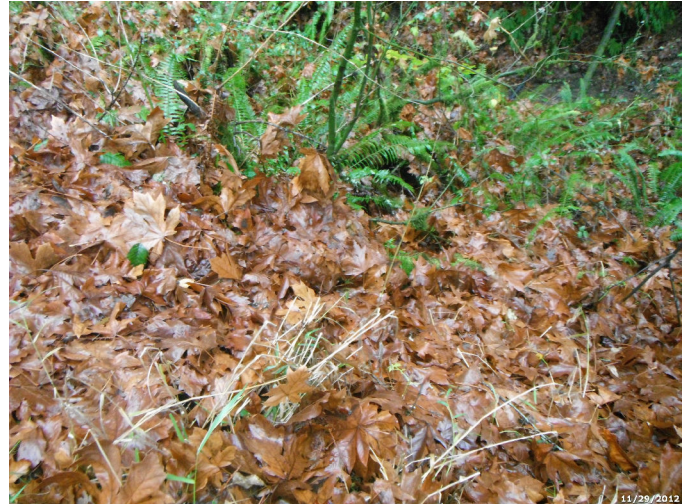
Photo: RIDG\_C4\_4206 Route: 010-001-0.29  
Metal Culvert 35ft long 18in dia. 2ft deep

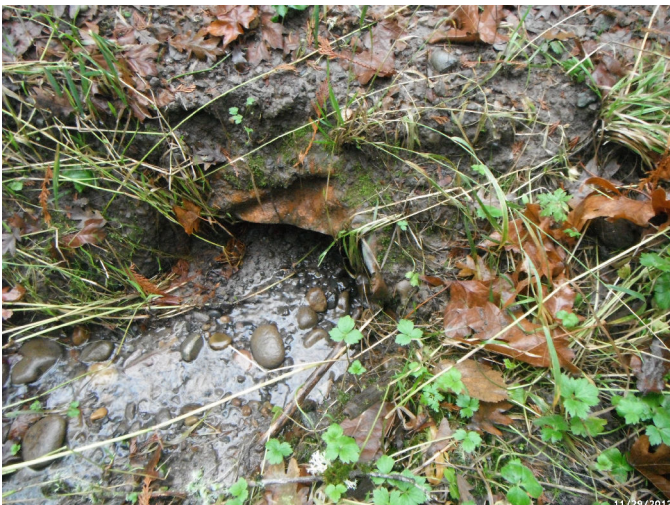
Photo: RIDG\_C4\_4207 Route: 010-001-0.29  
Metal Culvert 35ft long 18in dia. 2ft deep

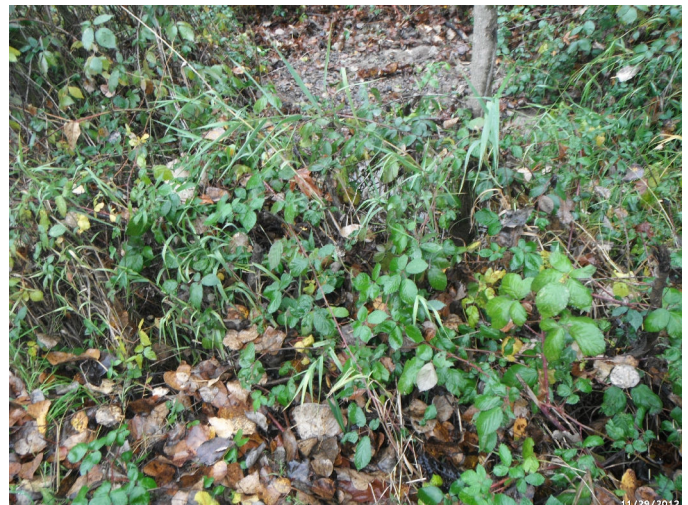
Photo: RIDG\_C4\_4208 Route: 010-001-0.34  
Metal Culvert 30ft long 24in dia. 2ft deep

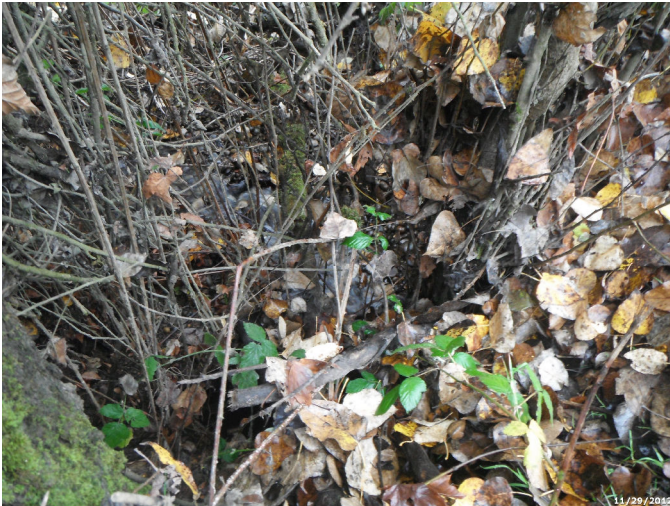
Photo: RIDG\_C4\_4209 Route: 010-001-0.34  
Metal Culvert 30ft long 24in dia. 2ft deep

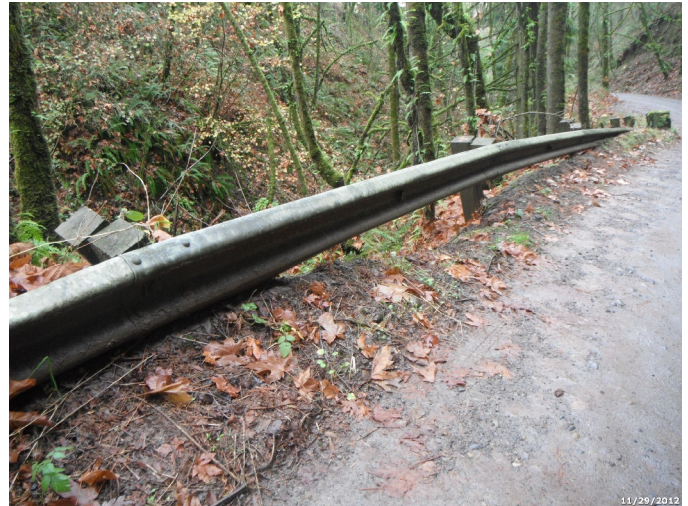
Photo: RIDG\_C4\_4212 Route: 010-001-0.22  
Guard\_Guide\_Rail  
Guardrail Galvanized\_Steel 75.0 ft long

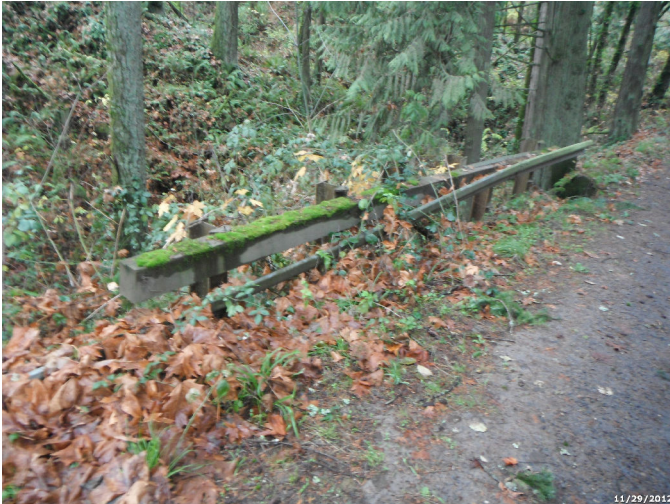
Photo: RIDG\_C4\_4213 Route: 010-001-0.18  
Guard\_Guide\_Rail  
Guardrail Galvanized\_Steel 24.0 ft long

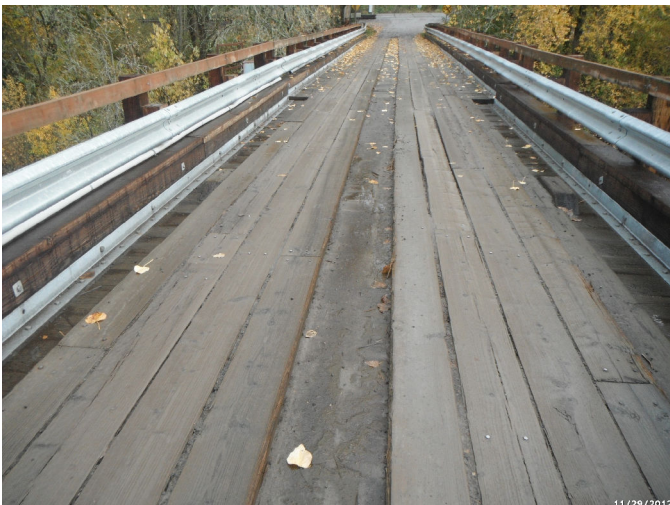
Photo: RIDG\_C4\_4220 Route: 010-002-0.43  
Wood Bridge NBIS:000013551-0000  
4225,4218

Ridgefield - 13551 Bridge Inventory					
Rte #	Milepost	NBIS #	Sufficiency Rating	Functionally Obsolete	Structurally Deficient
10	0.43	000013551-0000	259	NA	NA
411	0.48	13551-00092	NA	NA	NA

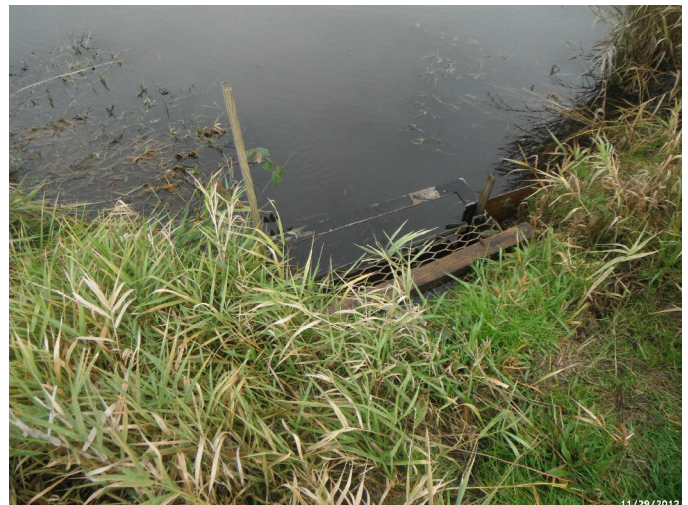
Photo: RIDG\_C4\_4226 Route: 010-002-0.69  
Metal WCS  
Flashboard Riser 40ft long 24in dia. 2ft deep

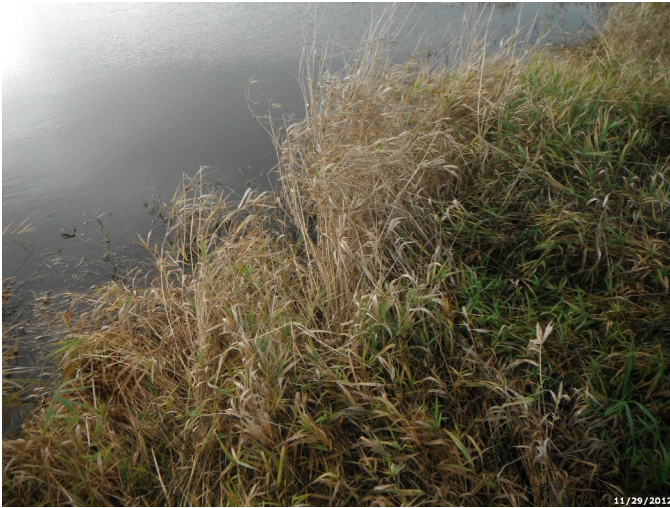
Photo: RIDG\_C4\_4227 Route: 010-002-0.69  
Metal WCS Flashboard Riser 40ft long 24in dia. 2ft deep

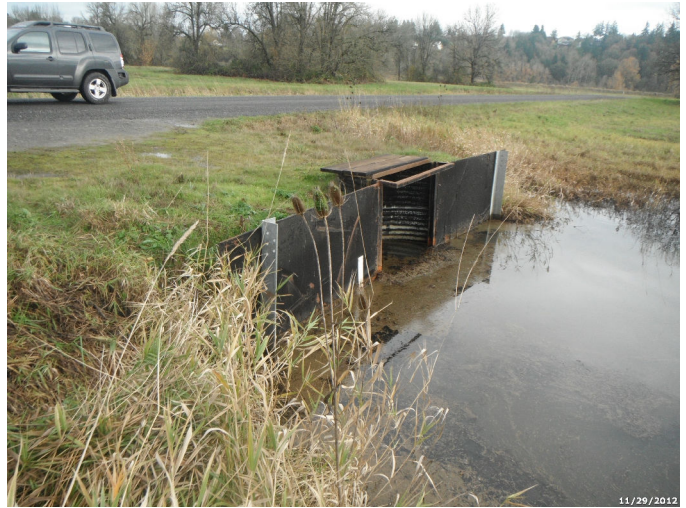
Photo: RIDG\_C4\_4228 Route: 010-002-0.89  
Metal WCS Flashboard Riser 60ft long 36in dia. 3ft deep

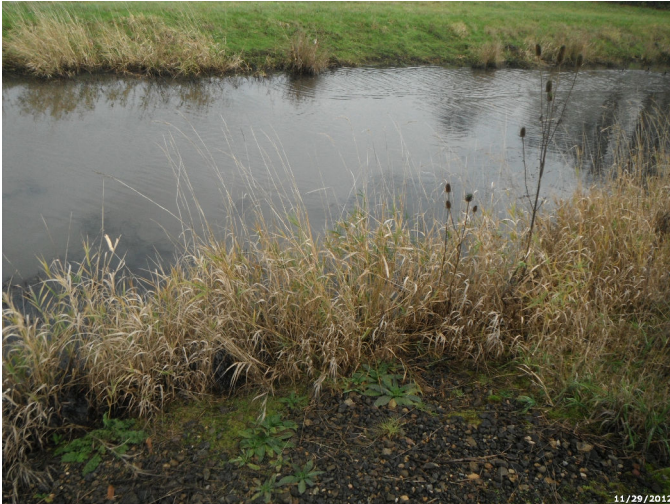
Photo: RIDG\_C4\_4229 Route: 010-002-0.89  
Metal WCS Flashboard Riser 60ft long 36in dia. 3ft deep

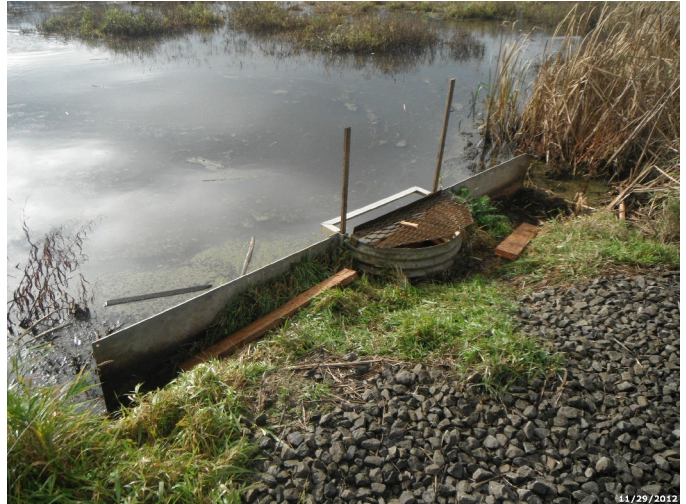
Photo: RIDG\_C4\_4233 Route: 010-002-0.99  
Metal WCS Flashboard Riser 40ft long 24in dia. 2ft deep

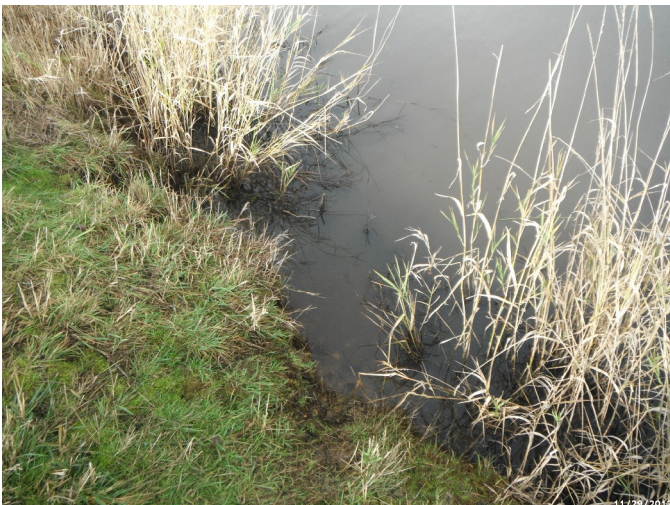
Photo: RIDG\_C4\_4234 Route: 010-002-0.99  
Metal WCS Flashboard Riser 40ft long 24in dia. 2ft deep

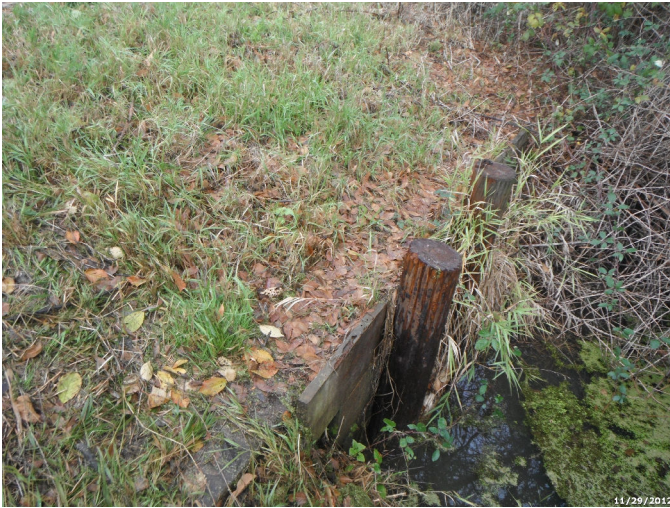
Photo: RIDG\_C4\_4236 Route: 010-003-1.43  
Metal WCS Flashboard Riser 30ft long 24in dia. 3ft deep

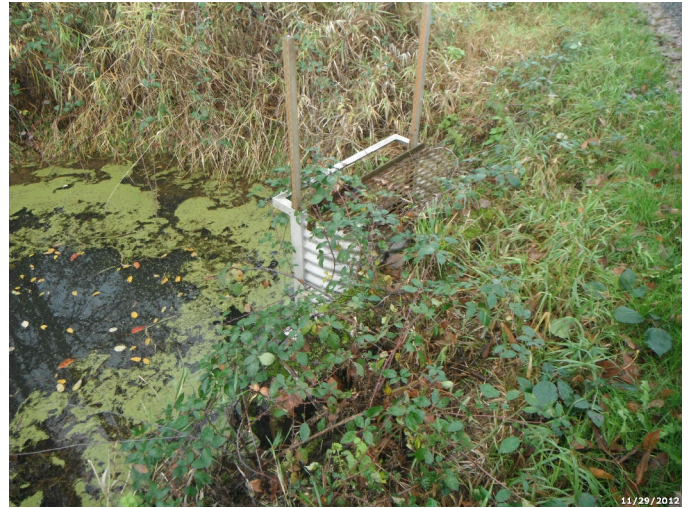
Photo: RIDG\_C4\_4237 Route: 010-003-1.43  
Metal WCS Flashboard Riser 30ft long 24in dia. 3ft deep

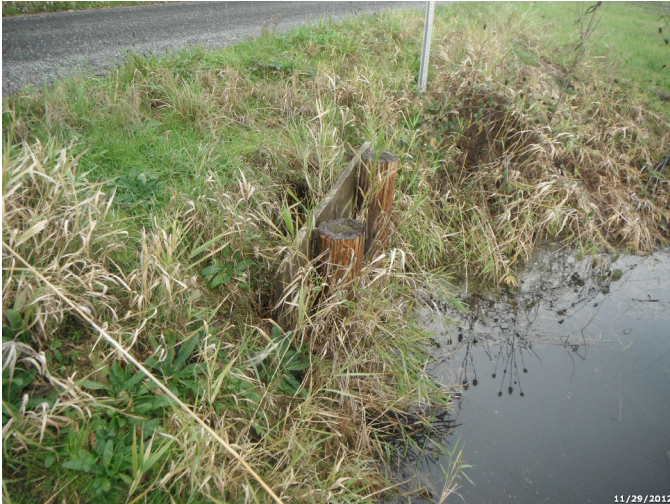
Photo: RIDG\_C4\_4241 Route: 010-003-1.59  
Metal WCS Flashboard Riser 30ft long 24in dia. 2ft deep

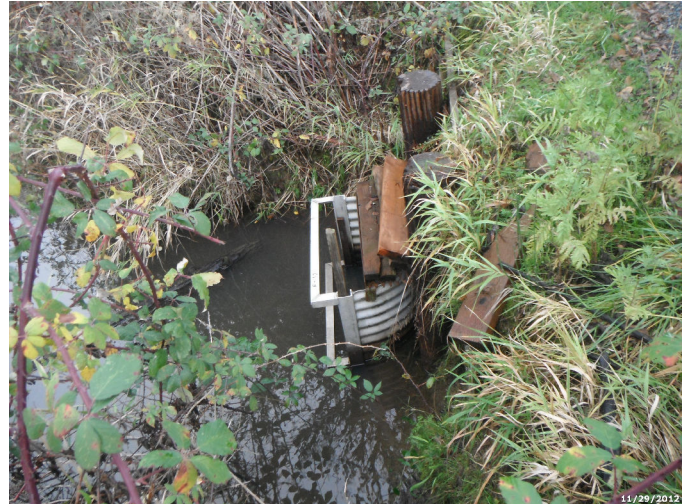
Photo: RIDG\_C4\_4242 Route: 010-003-1.59  
Metal WCS Flashboard Riser 30ft long 24in dia. 2ft deep

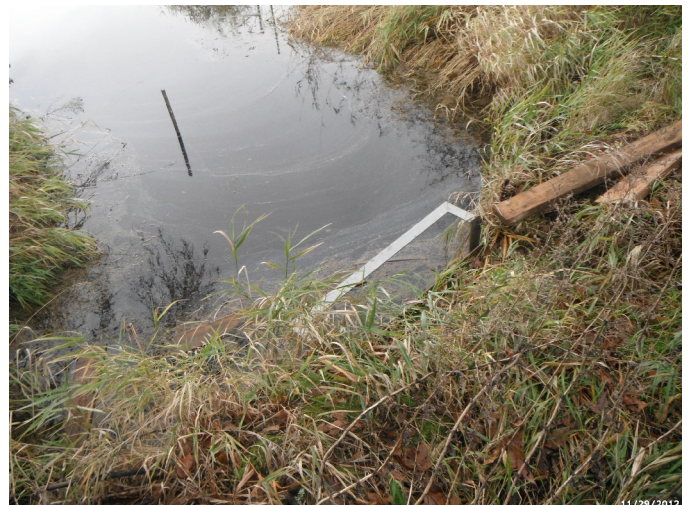
Photo: RIDG\_C4\_4244 Route: 010-004-2.16  
Metal WCS Flashboard Riser 30ft long 24in dia. 2ft deep  
8-005

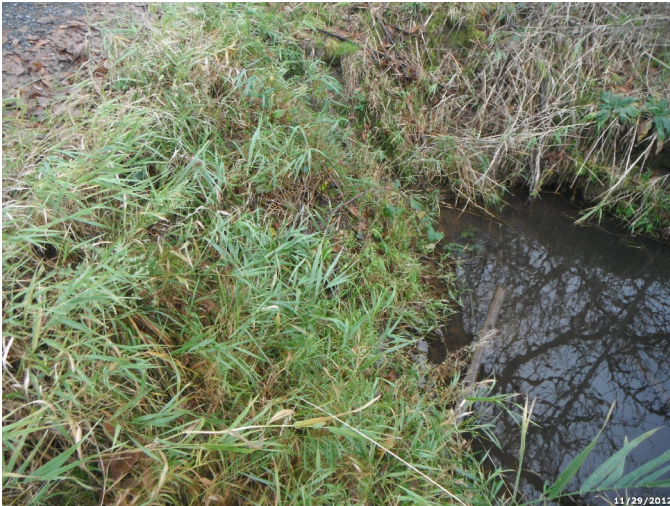
Photo: RIDG\_C4\_4245 Route: 010-004-2.16  
Metal WCS Flashboard Riser 30ft long 24in dia. 2ft deep

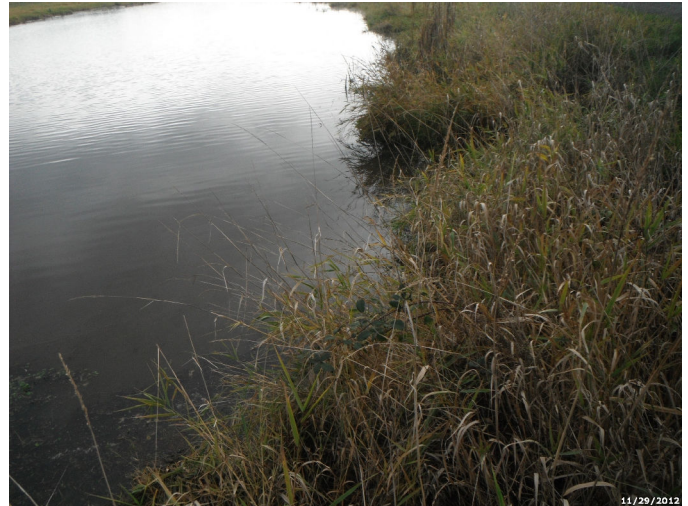
Photo: RIDG\_C4\_4249 Route: 010-004-2.81  
Metal WCS Flashboard Riser 30ft long 24in dia. 2ft deep

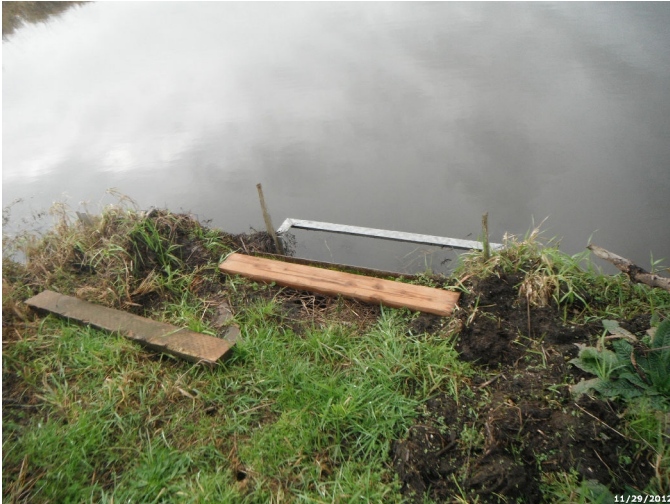
Photo: RIDG\_C4\_4250 Route: 010-004-2.81  
Metal WCS Flashboard Riser 30ft long 24in dia. 2ft deep

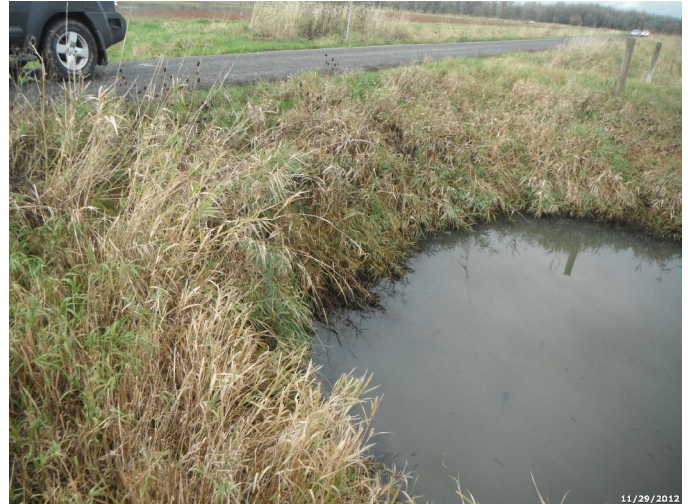
Photo: RIDG\_C4\_4254 Route: 010-004-3.03  
Metal WCS Flashboard Riser 60ft long 24in dia. 3ft deep

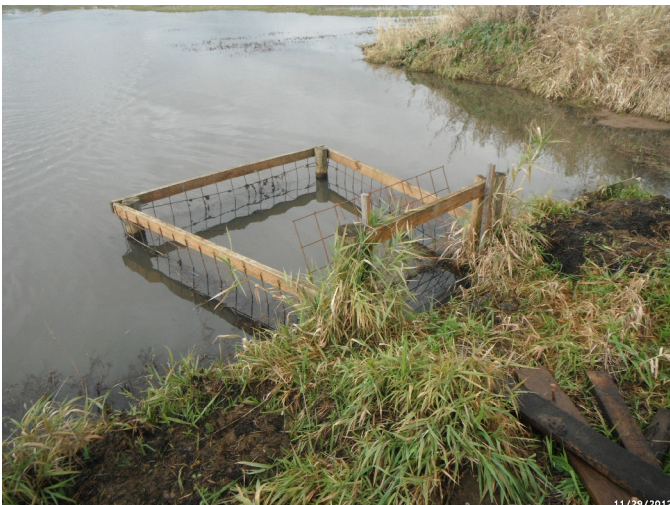
Photo: RIDG\_C4\_4255 Route: 010-004-3.03  
Metal WCS Flashboard Riser 60ft long 24in dia. 3ft deep

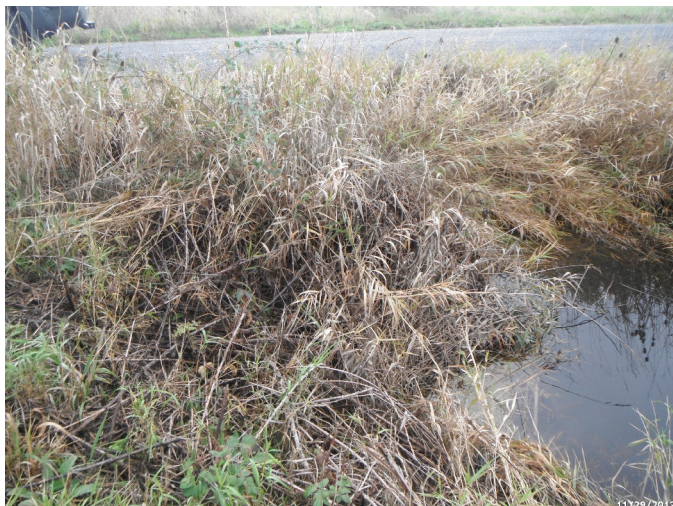
Photo: RIDG\_C4\_4259 Route: 010-005-3.11  
Metal WCS Flashboard Riser 30ft long 24in dia. 3ft deep

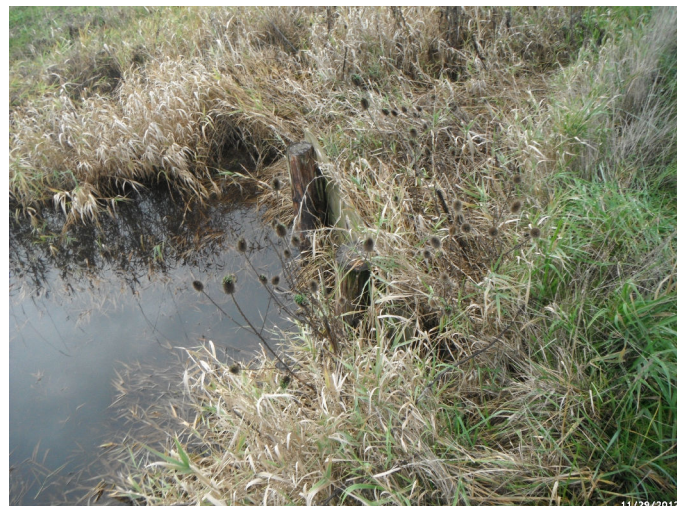
Photo: RIDG\_C4\_4260 Route: 010-005-3.11  
Metal WCS Flashboard Riser 30ft long 24in dia. 3ft deep

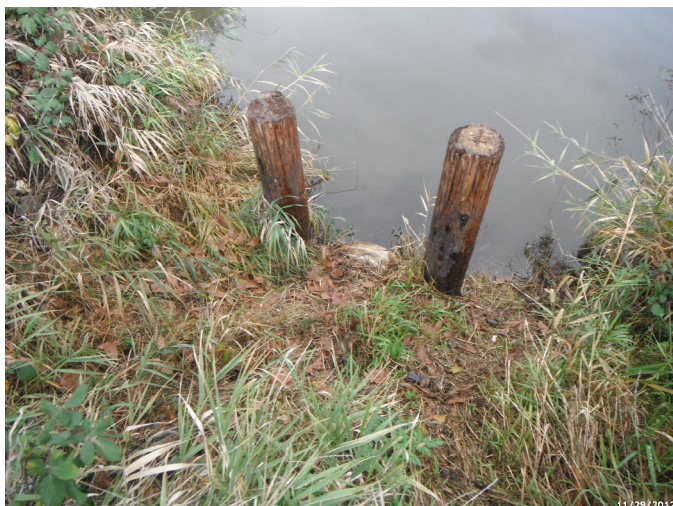
Photo: RIDG\_C4\_4261 Route: 010-005-3.45  
Metal WCS Flashboard Riser 30ft long 24in dia. 4ft deep

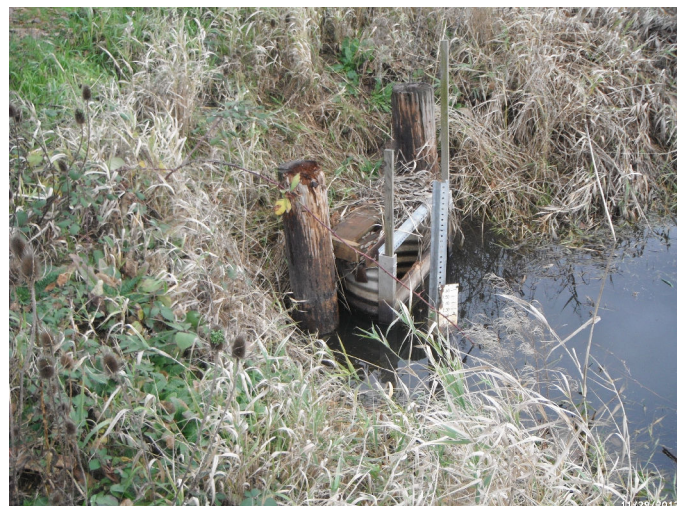
Photo: RIDG\_C4\_4262 Route: 010-005-3.45  
Metal WCS Flashboard Riser 30ft long 24in dia. 4ft deep

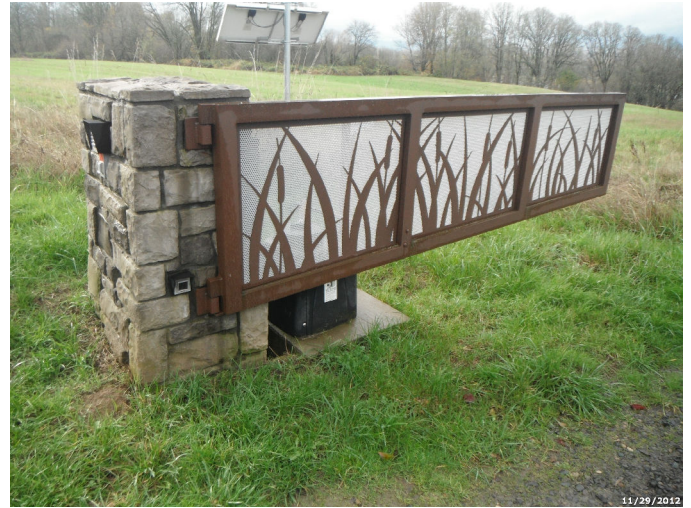
Photo: RIDG\_C4\_4185 Route: 100-001-0.0  
Metal Gate Electric

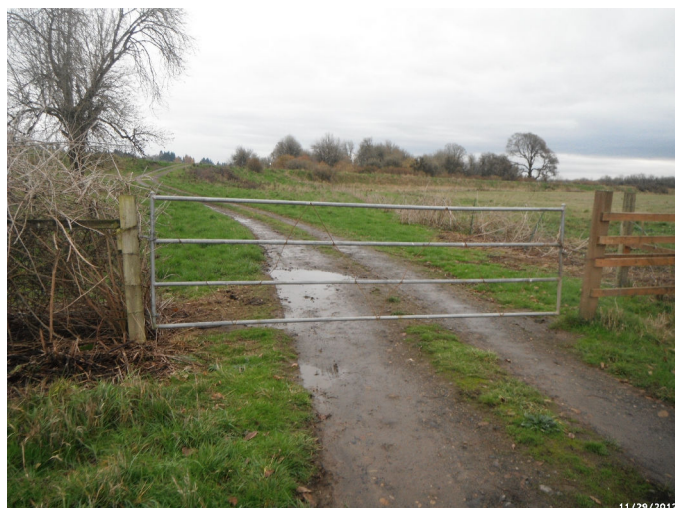
Photo: RIDG\_C4\_4283 Route: 400-001-0.14  
Metal Open Rail Gate

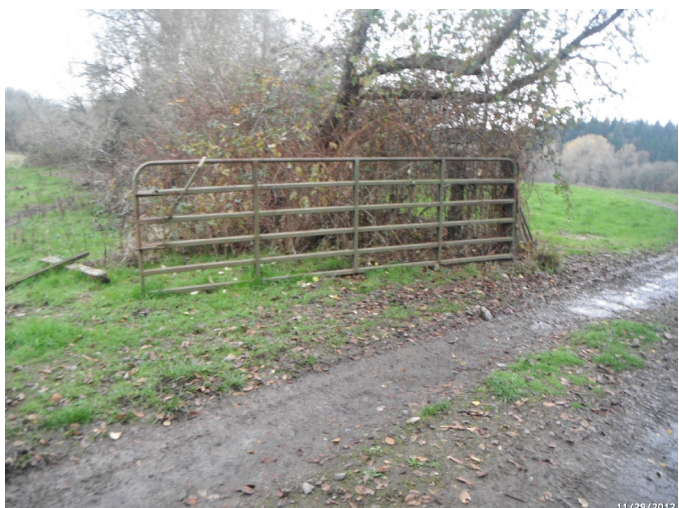
Photo: RIDG\_C4\_4284 Route: 400-001-0.47  
Metal Open Rail Gate

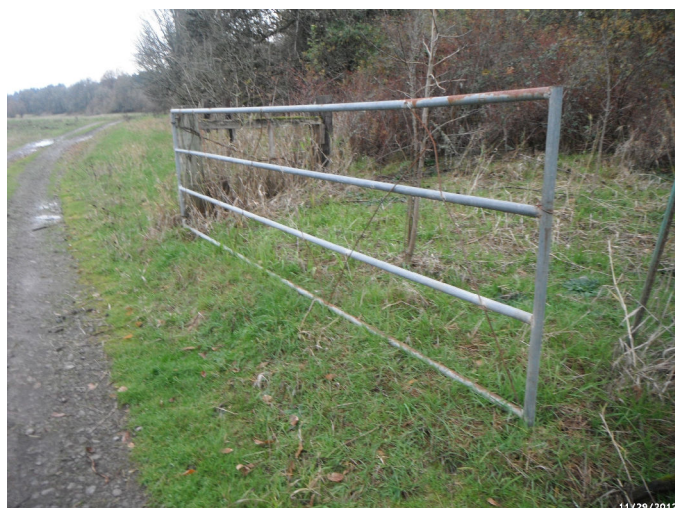
Photo: RIDG\_C4\_4285 Route: 400-001-0.65  
Metal Open Rail Gate

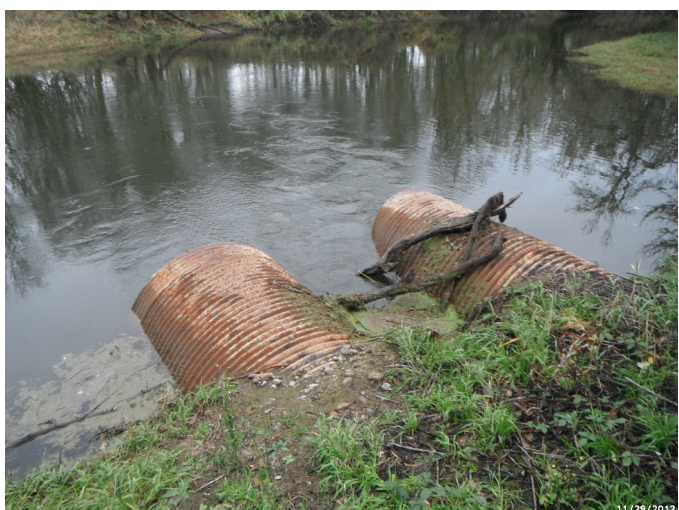
Photo: RIDG\_C4\_4287 Route: 400-002-1.03  
Metal Culvert 50ft long 72in dia. 8ft deep

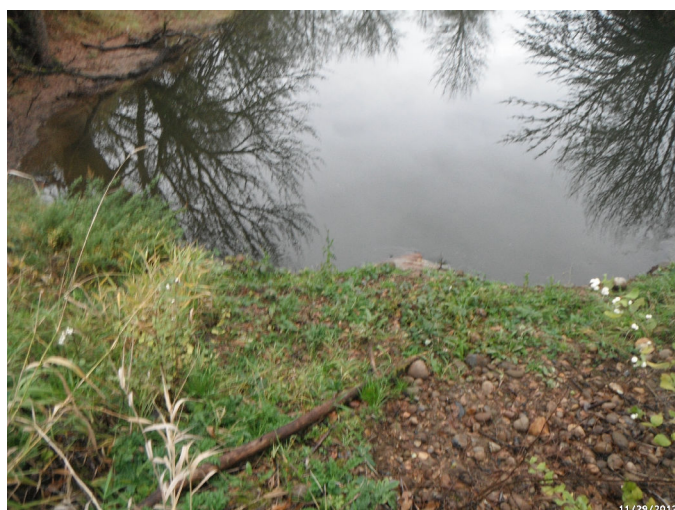
Photo: RIDG\_C4\_4288 Route: 400-002-1.03  
Metal Culvert 50ft long 72in dia. 8ft deep

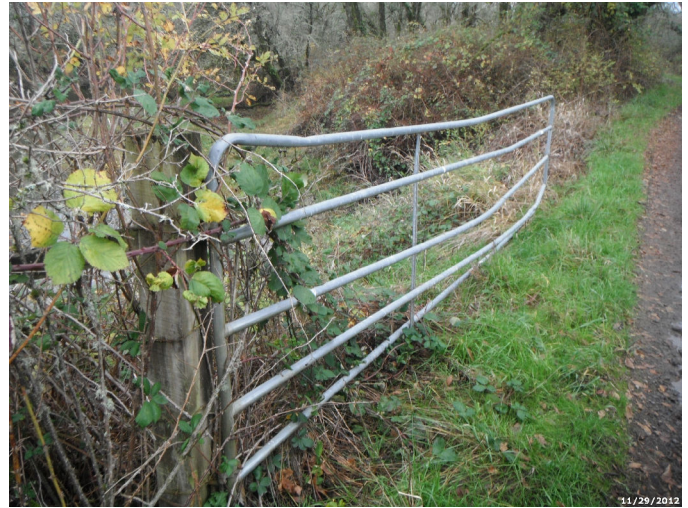
Photo: RIDG\_C4\_4286 Route: 400-002-1.03  
Metal Open Rail Gate

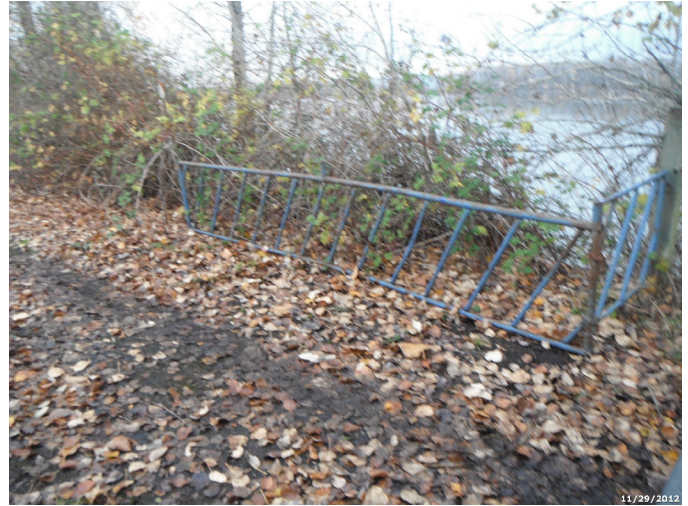
Photo: RIDG\_C4\_4291 Route: 400-003-1.67  
Metal Open Rail Gate

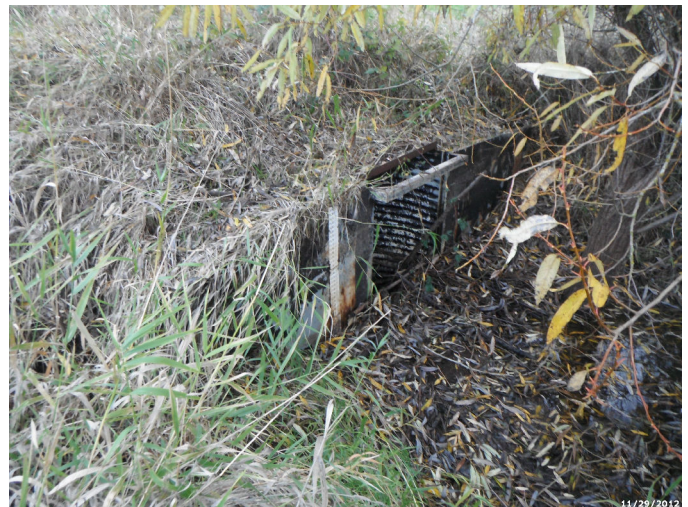
Photo: RIDG\_C4\_4295 Route: 400-004-2.01  
Metal WCS Flashboard Riser 40ft long 24in dia. 5ft deep  
8-010

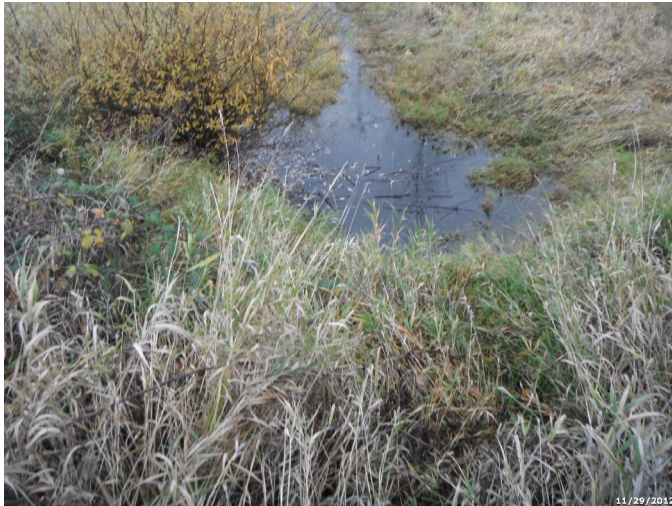
Photo: RIDG\_C4\_4296 Route: 400-004-2.01  
Metal WCS Flashboard Riser 40ft long 24in dia. 5ft deep

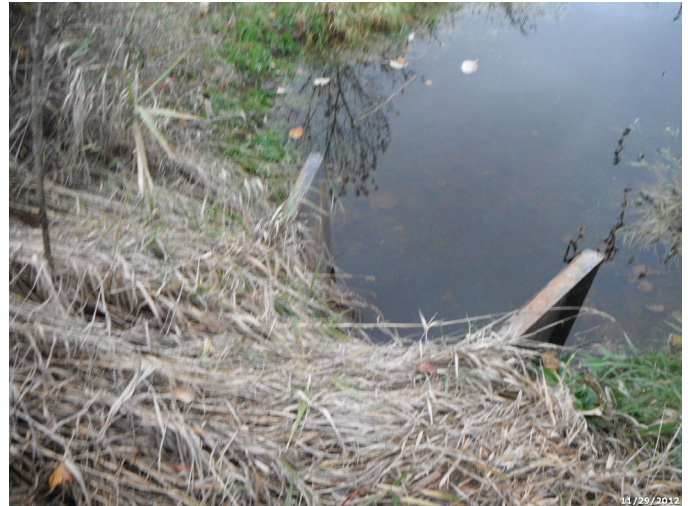
Photo: RIDG\_C4\_4293 Route: 400-004-2.23  
Metal WCS Flashboard Riser 40ft long 24in dia. 5ft deep

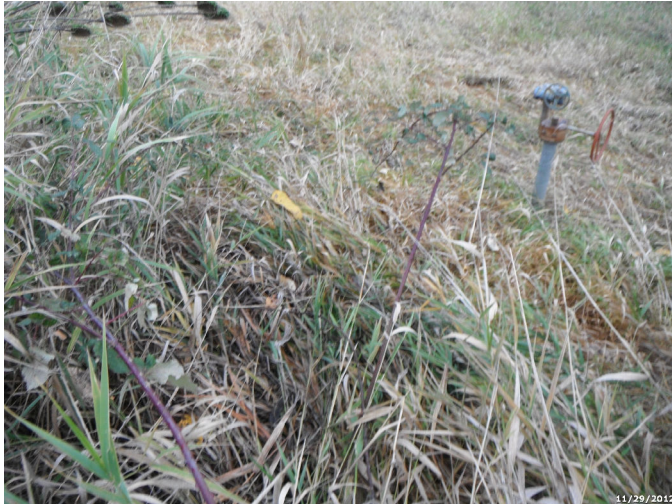
Photo: RIDG\_C4\_4294 Route: 400-004-2.23  
Metal WCS Flashboard Riser 40ft long 24in dia. 5ft deep

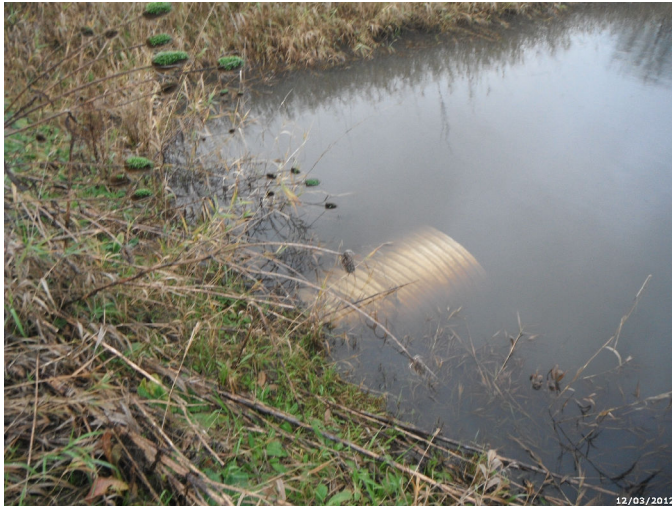
Photo: RIDG\_C4\_4309 Route: 401-001-0.0  
Metal Culvert 40ft long 36in dia. 5ft deep

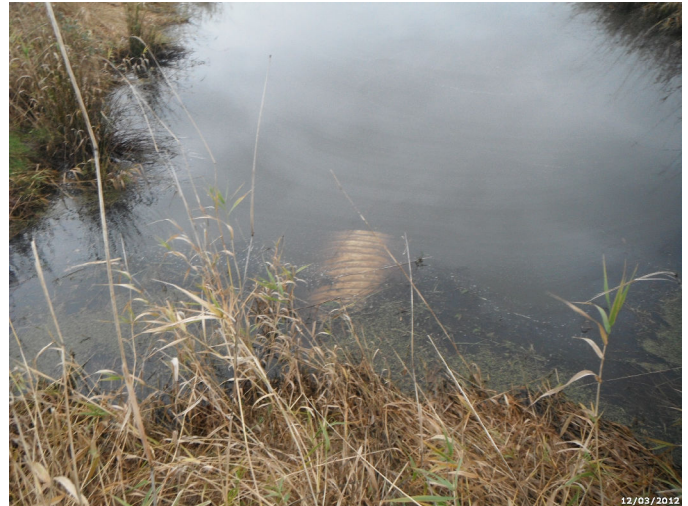
Photo: RIDG\_C4\_4310 Route: 401-001-0.0  
Metal Culvert 40ft long 36in dia. 5ft deep

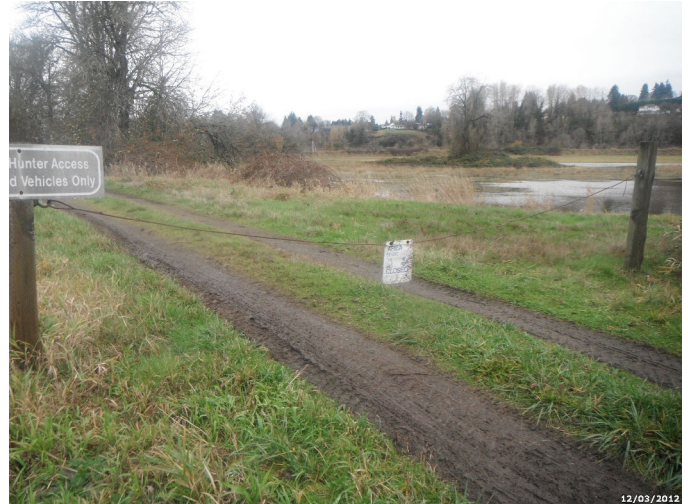
Photo: RIDG\_C4\_4383 Route: 401-001-0.01  
Metal Cable Gate

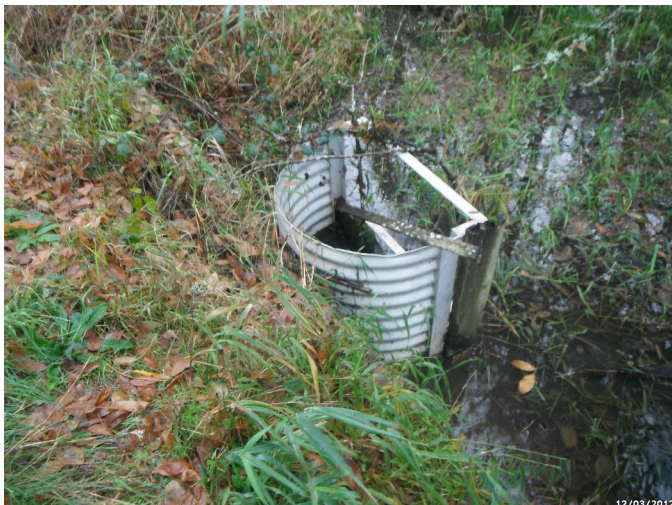
Photo: RIDG\_C4\_4311 Route: 401-001-0.09  
Metal WCS Flashboard Riser 30ft long 24in dia. 2ft deep

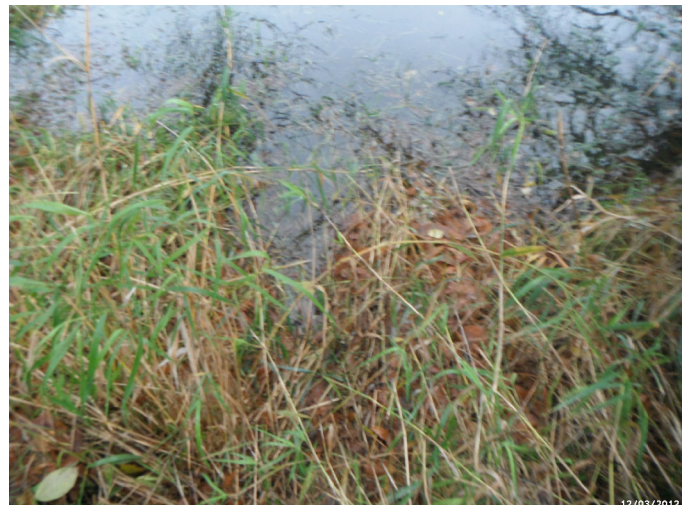
Photo: RIDG\_C4\_4312 Route: 401-001-0.09  
Metal WCS  
Flashboard Riser 30ft long 24in dia. 2ft deep

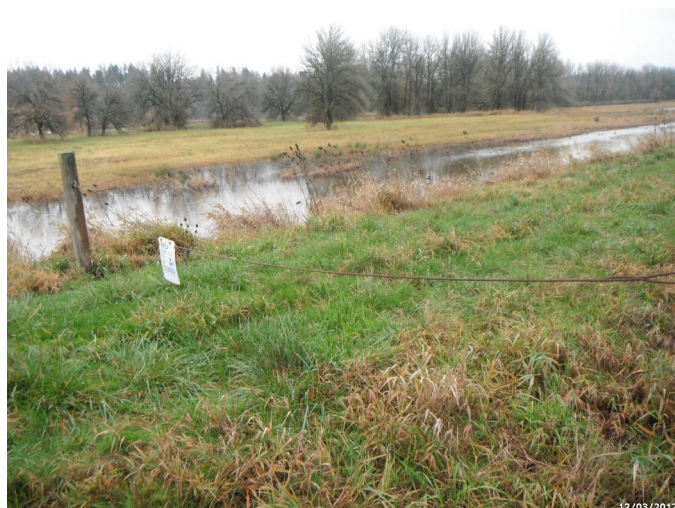
Photo: RIDG\_C4\_4316 Route: 402-001-0.01  
Metal Cable Gate

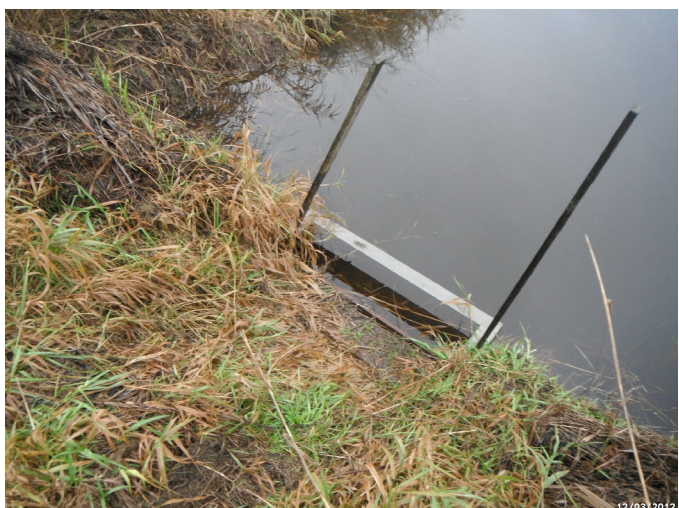
Photo: RIDG\_C4\_4317 Route: 402-001-0.32  
Metal WCS Flashboard Riser 30ft long 24in dia. 2ft deep

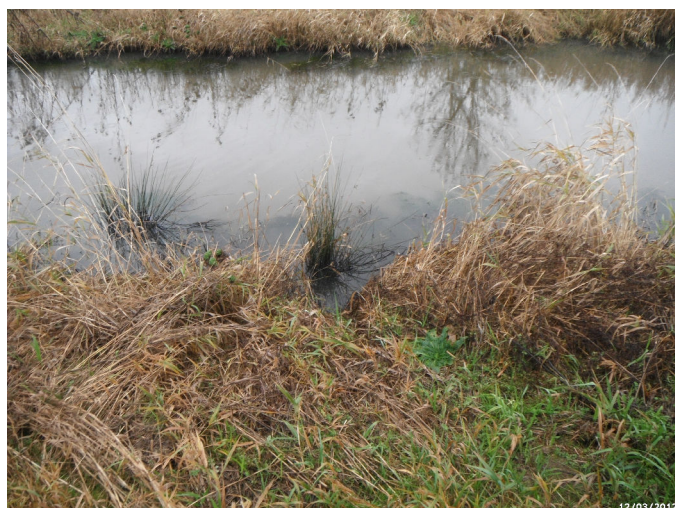
Photo: RIDG\_C4\_4318 Route: 402-001-0.32  
Metal WCS Flashboard Riser 30ft long 24in dia. 2ft deep

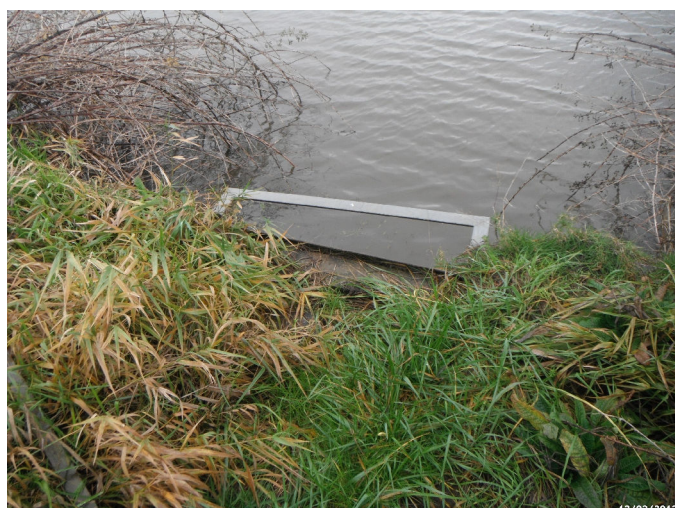
Photo: RIDG\_C4\_4320 Route: 402-002-0.64  
Metal WCS  
Flashboard Riser 30ft long 24in dia. 3ft deep

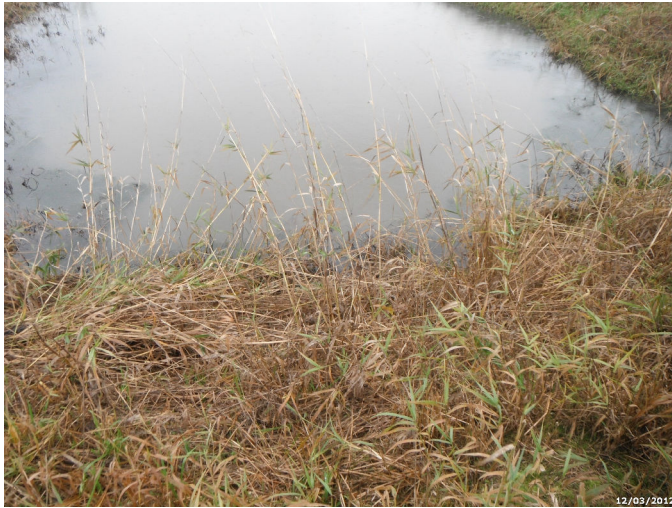
Photo: RIDG\_C4\_4321 Route: 402-002-0.64  
Metal WCS Flashboard Riser 30ft long 24in dia. 3ft deep

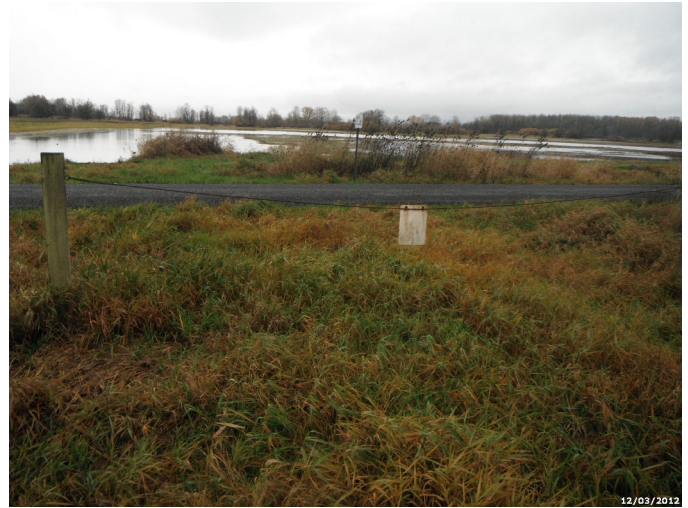
Photo: RIDG\_C4\_4324 Route: 402-002-1.37  
Metal Cable Gate

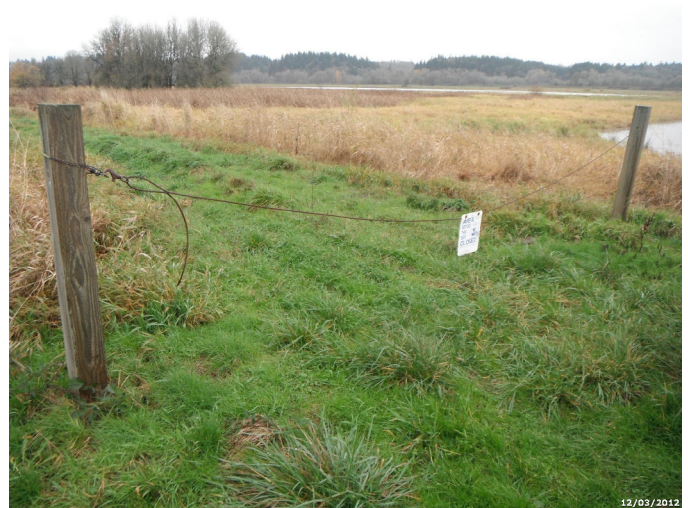
Photo: RIDG\_C4\_4326 Route: 403-001-0.01  
Metal Cable Gate

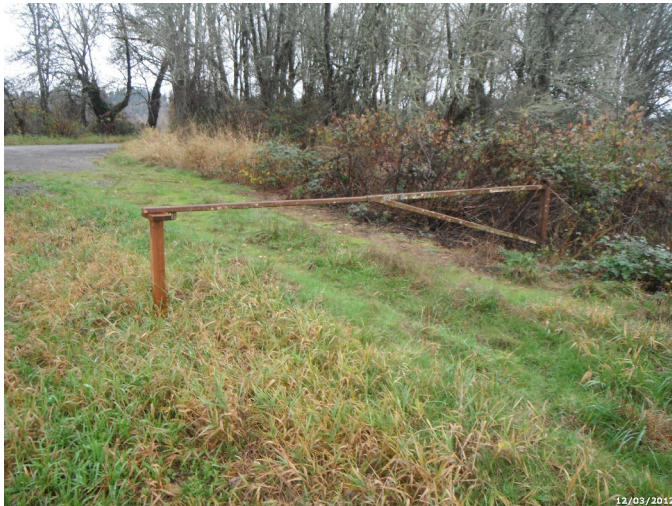
Photo: RIDG\_C4\_4327 Route: 403-001-0.5  
Metal Open Rail Gate

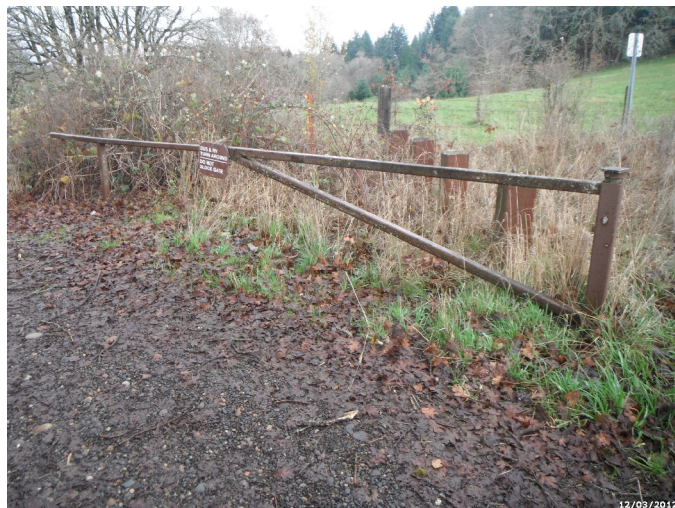
Photo: RIDG\_C4\_4329 Route: 404-001-0.0  
Metal Open Rail Gate

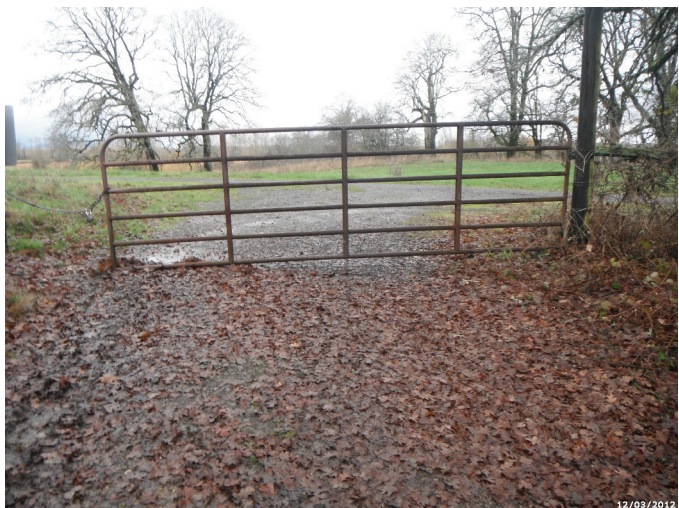
Photo: RIDG\_C4\_4330 Route: 404-001-0.08  
Metal Open Rail Gate

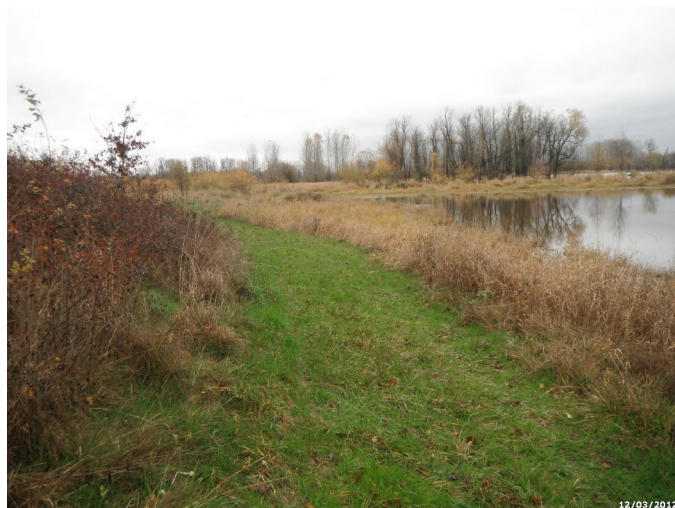
Photo: RIDG\_C4\_4331 Route: 404-001-0.14  
Problem Area Road Flooded

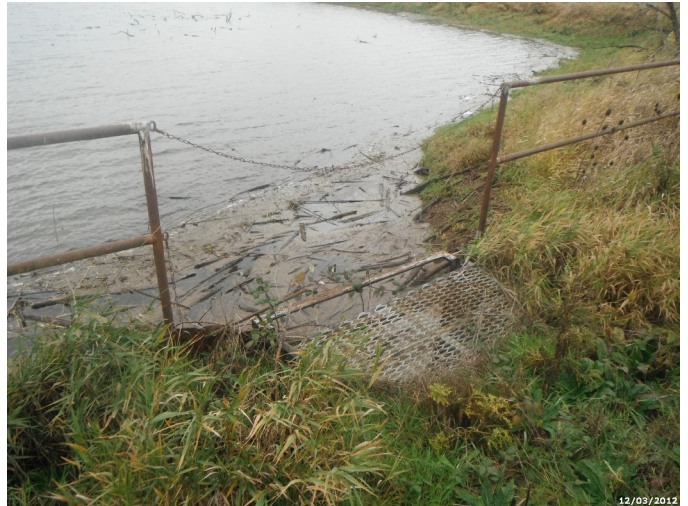
Photo: RIDG\_C4\_4333 Route: 405-001-0.27  
Metal WCS Flashboard Riser 50ft long 48in dia. 6ft deep

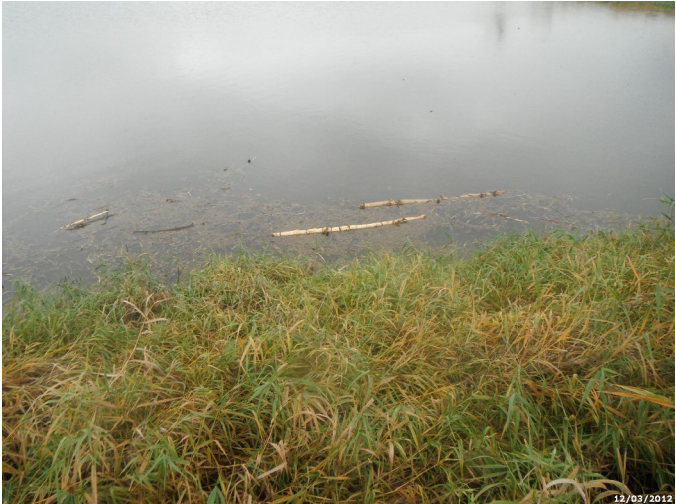
Photo: RIDG\_C4\_4334 Route: 405-001-0.27  
Metal WCS Flashboard Riser 50ft long 48in dia. 6ft deep

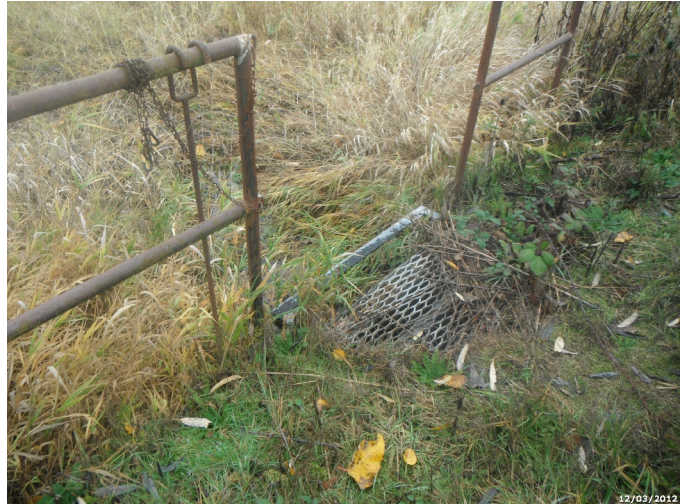
Photo: RIDG\_C4\_4335 Route: 405-001-0.41  
Metal WCS Flashboard Riser 40ft long 24in dia. 2ft deep
